Shackleford-Mill Road Erosion Reduction
Project

Final Report

The Siskiyou Resource Conservation District

2/15/03

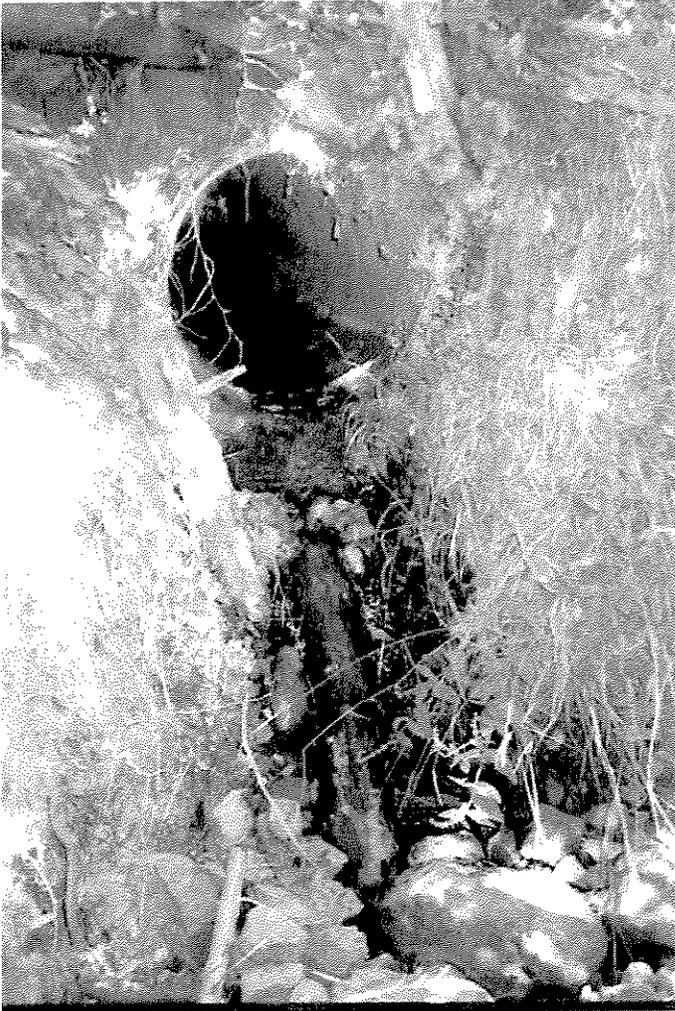
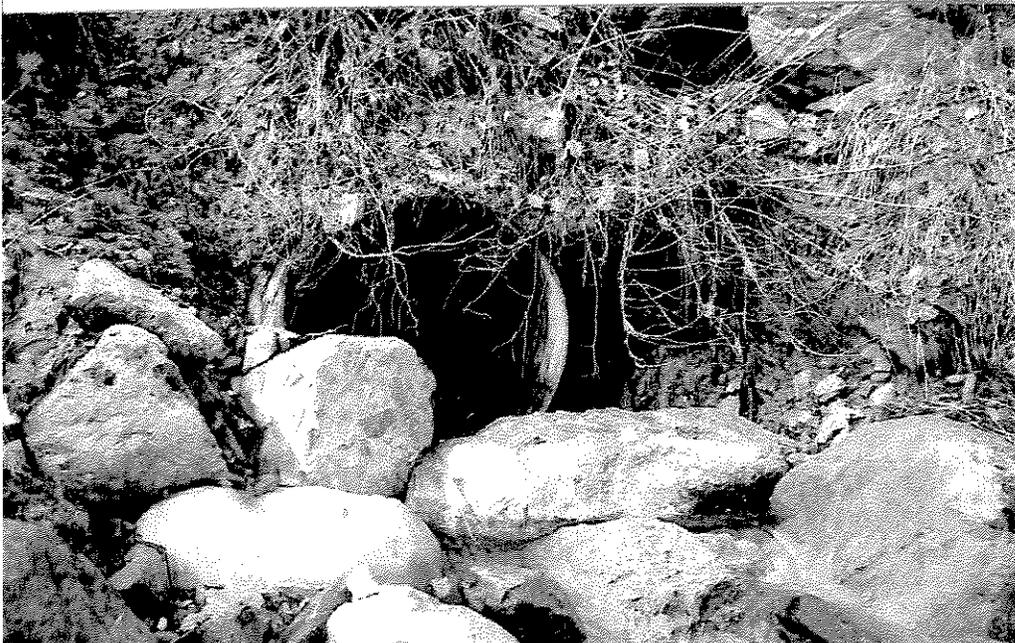
Top: US-19 before treatment

Bottom: US-19 after treatment

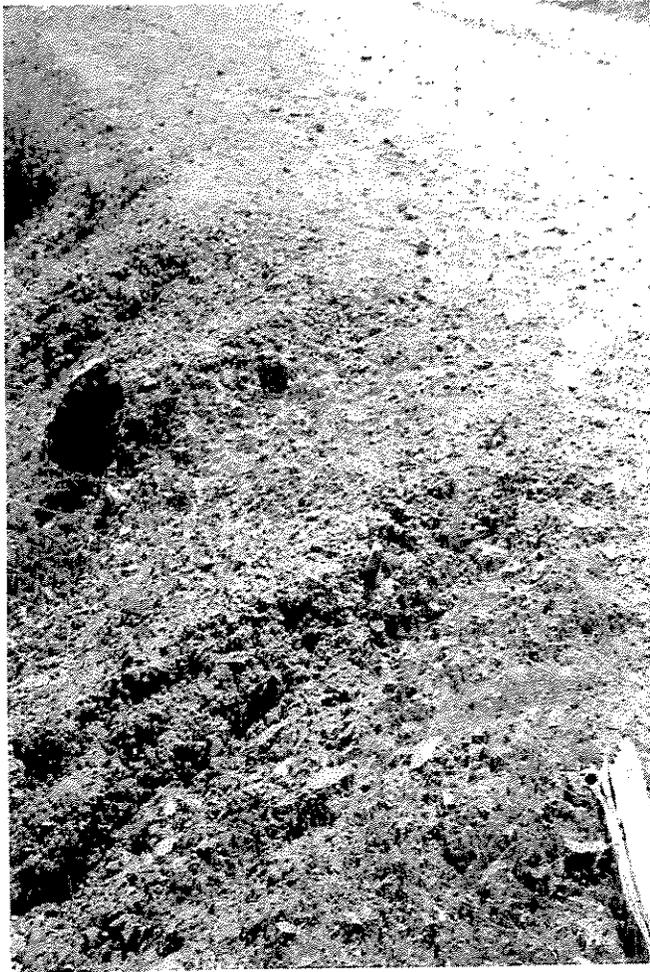
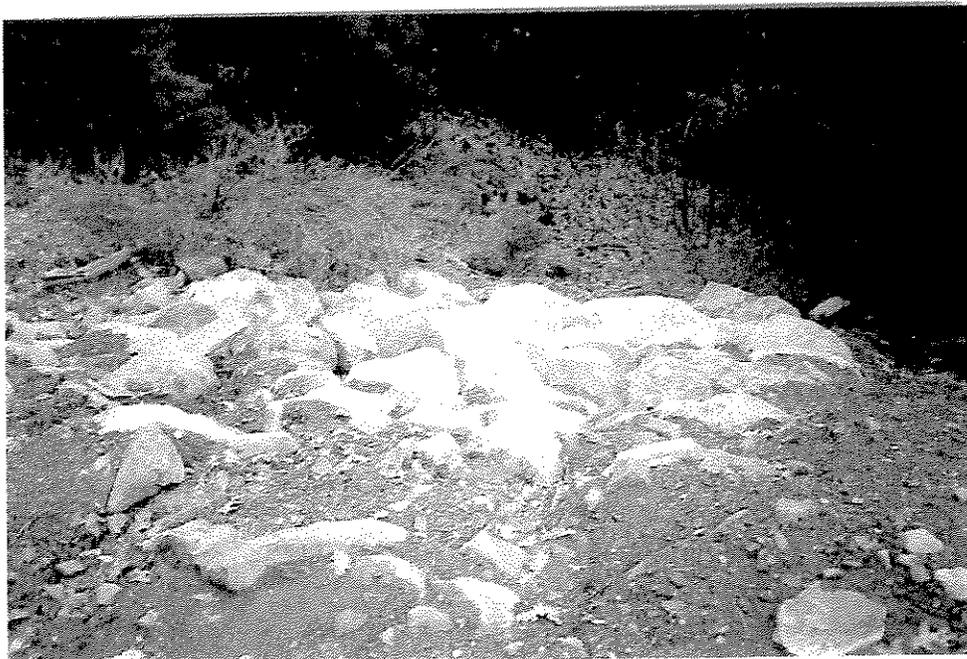
Top: Site US-3 Before treatment
Bottom: Site US-3 After treatment

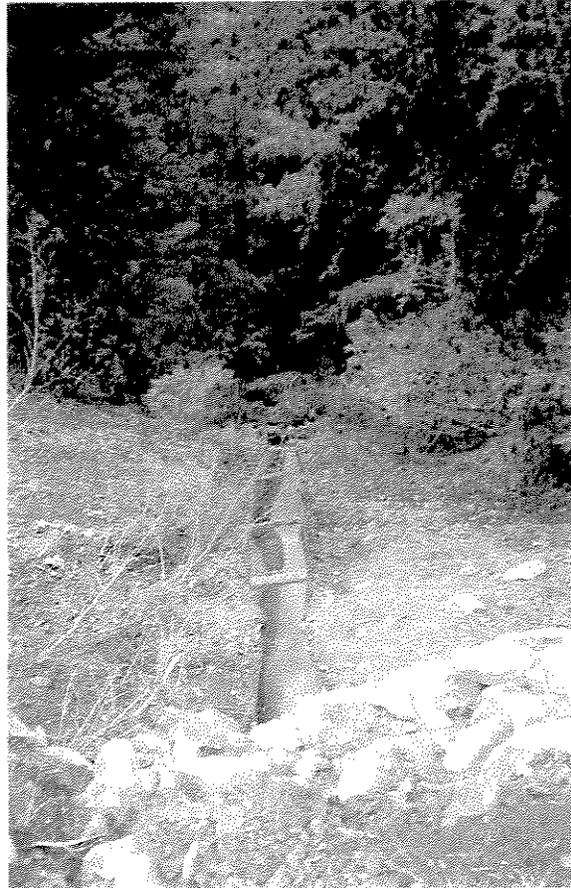
Site US-5 after treatment

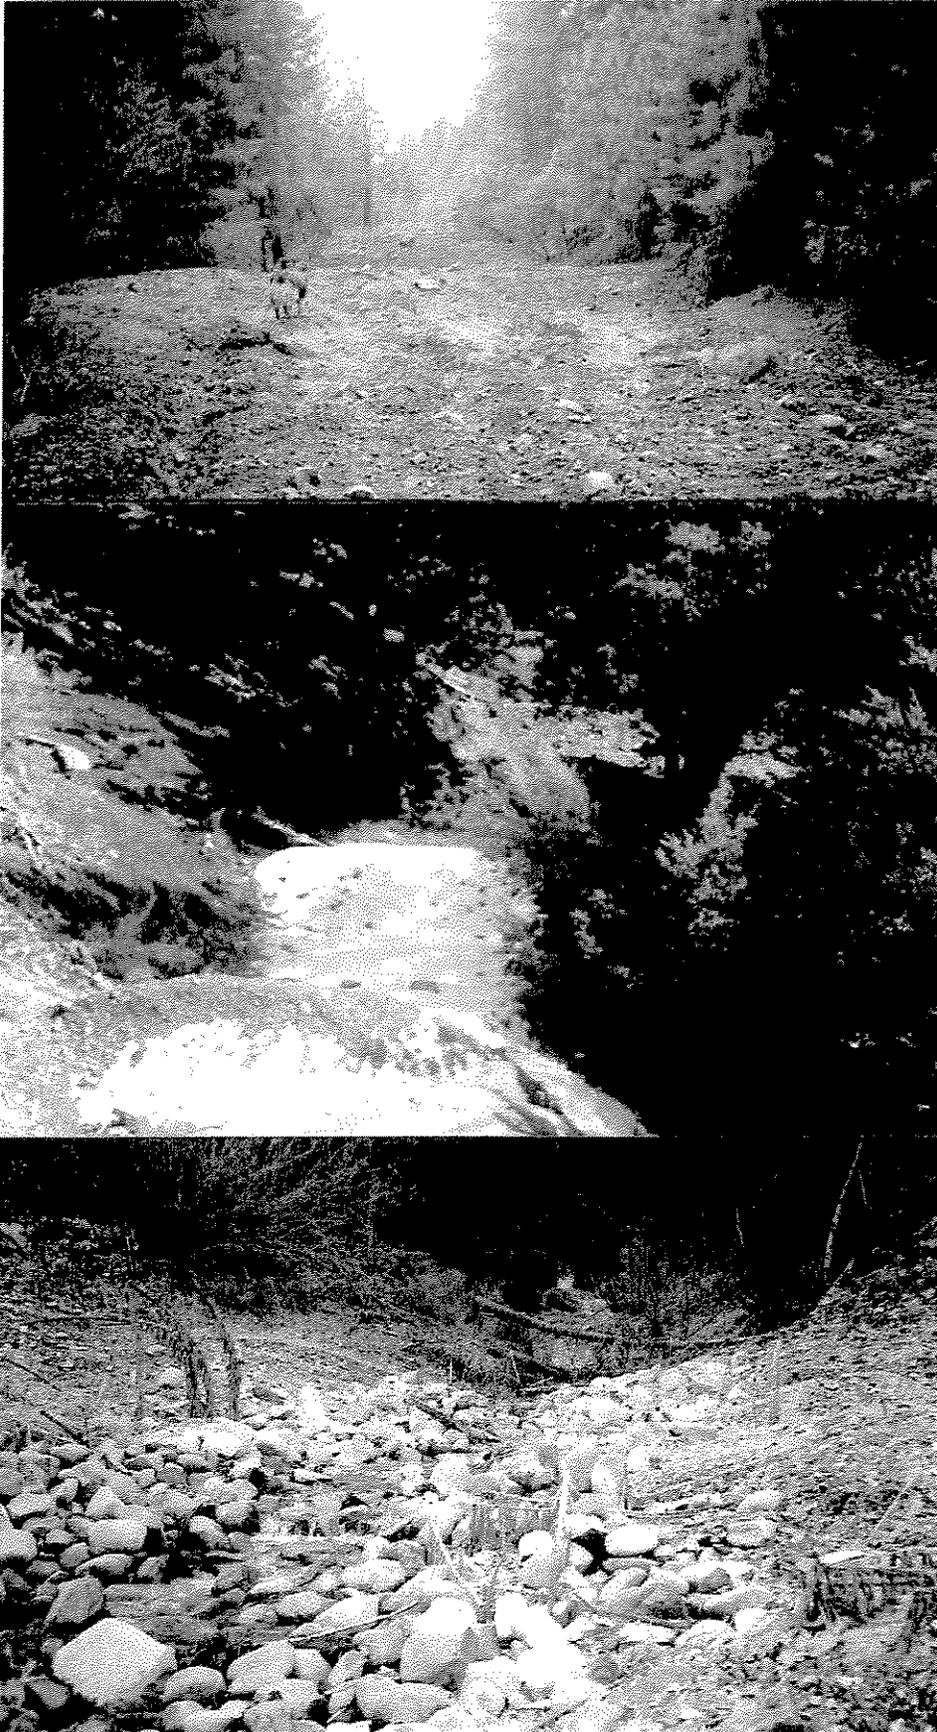
Top and middle: Decommission of road base
Bottom: Decommission of stream crossing US6-13

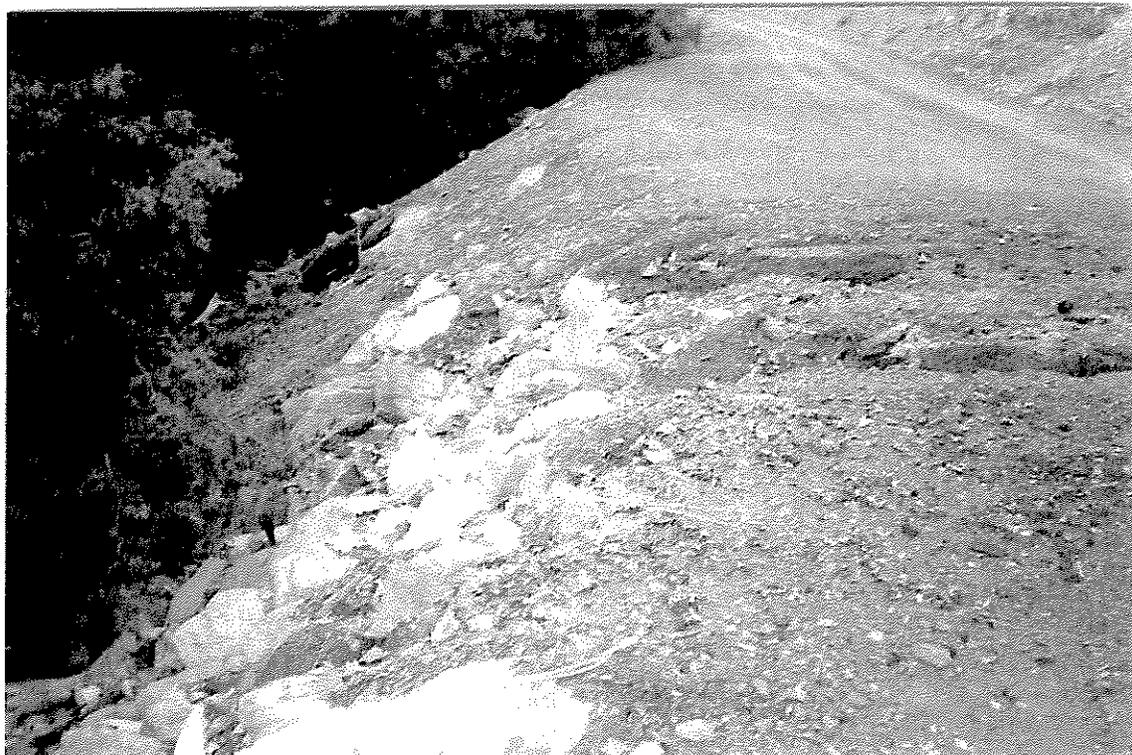
Top: US-7 before treatment
Bottom: US-7 after treatment

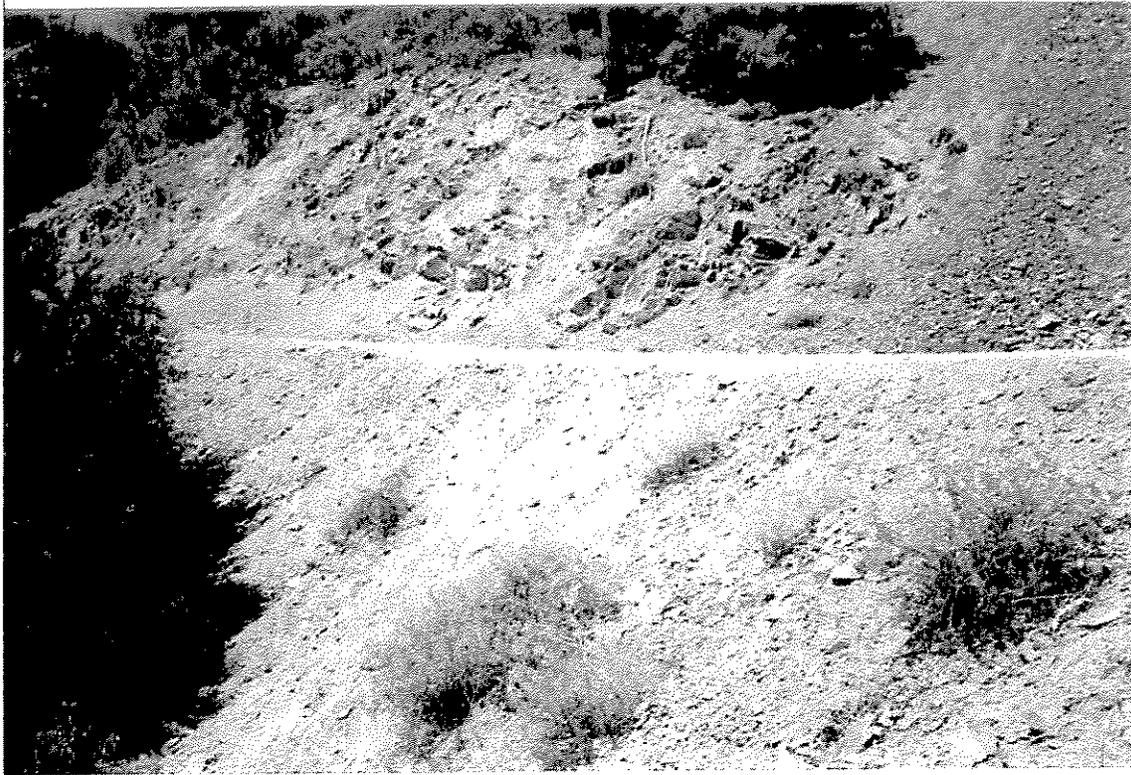
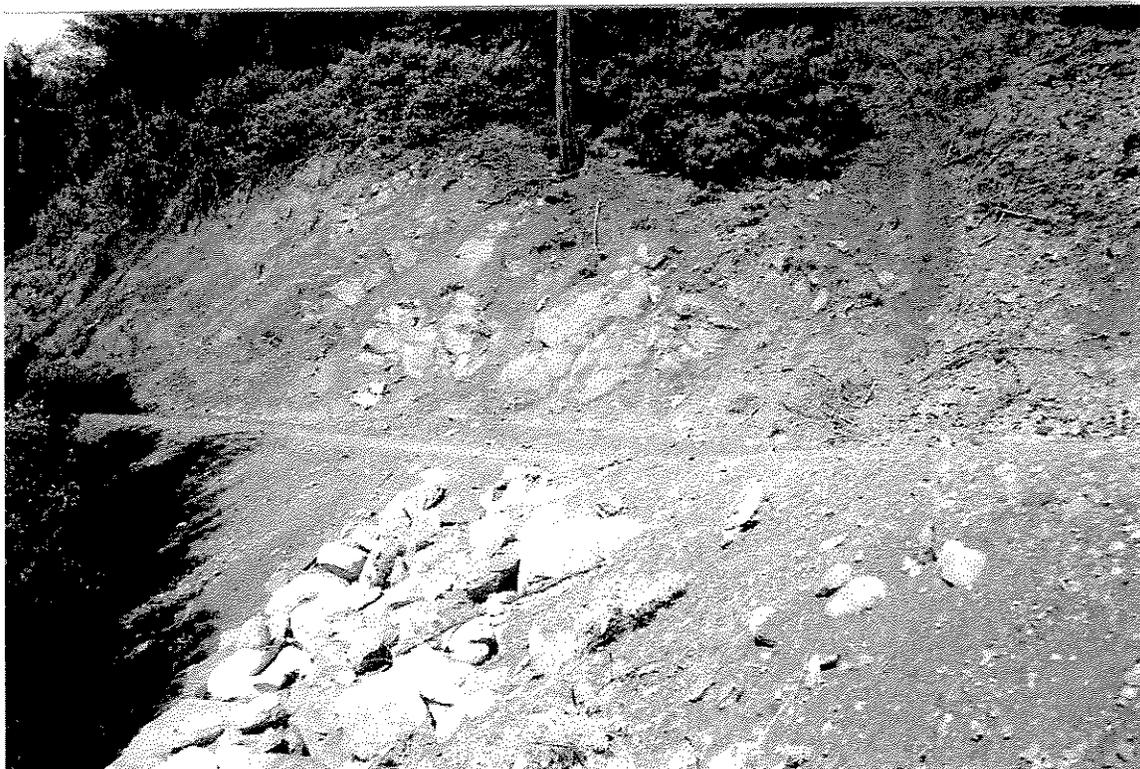
Top: Site US-8 before treatment

Bottom: Site US-8 after treatment

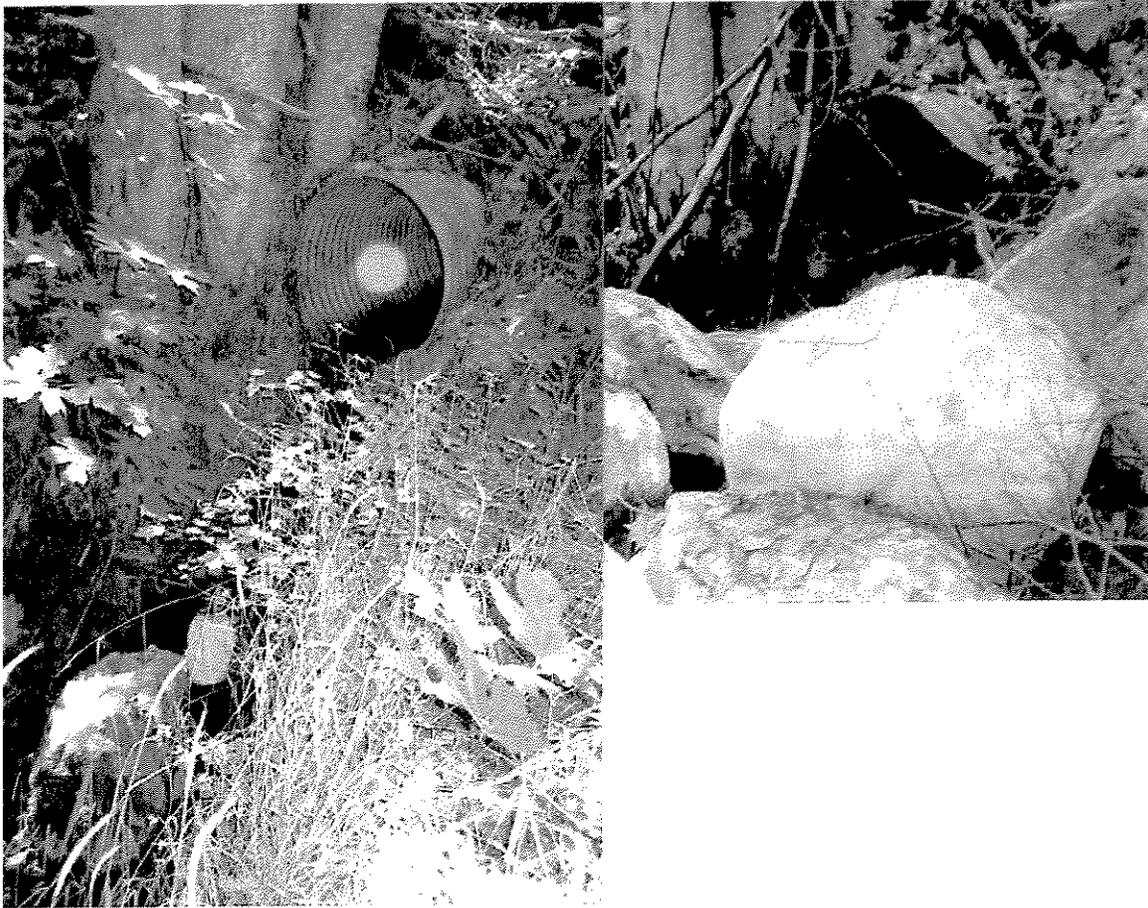
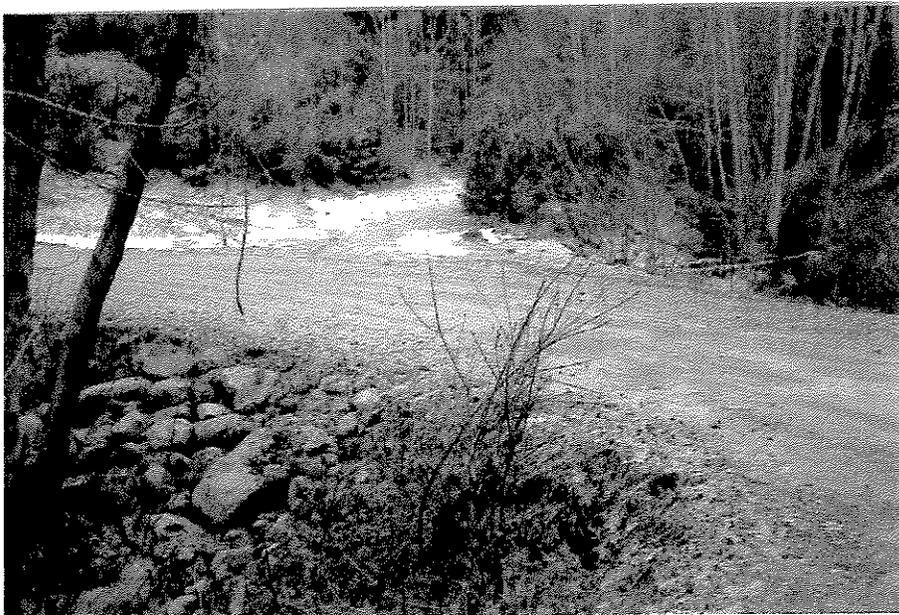
Top: Site US-9 before and after

Bottom: Overview photo of Site US-9 showing armored fill slope and safe outlet

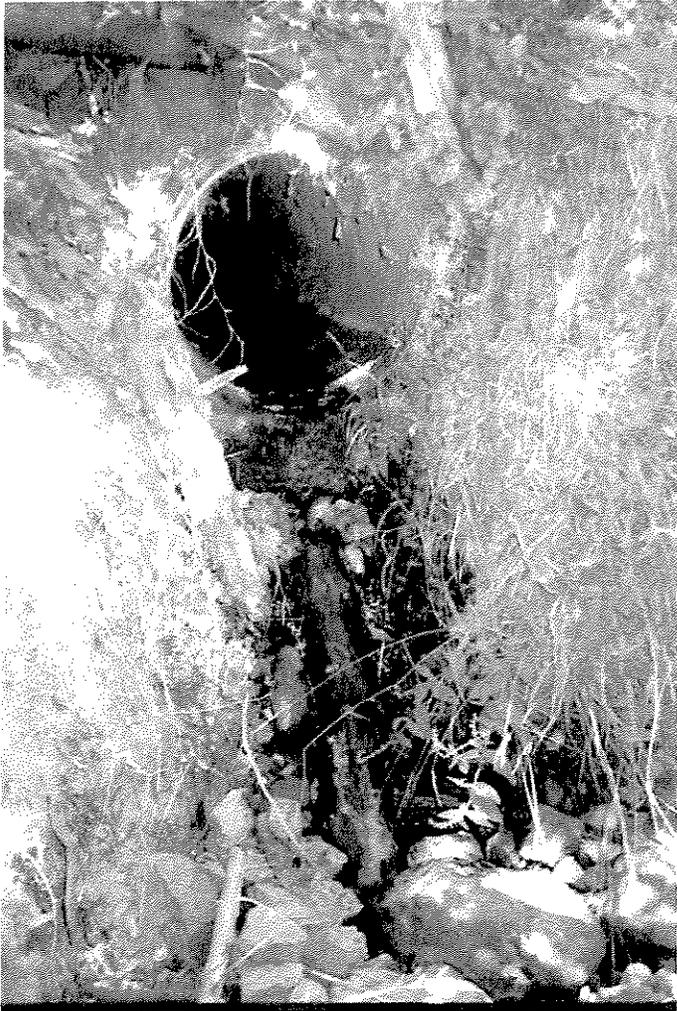
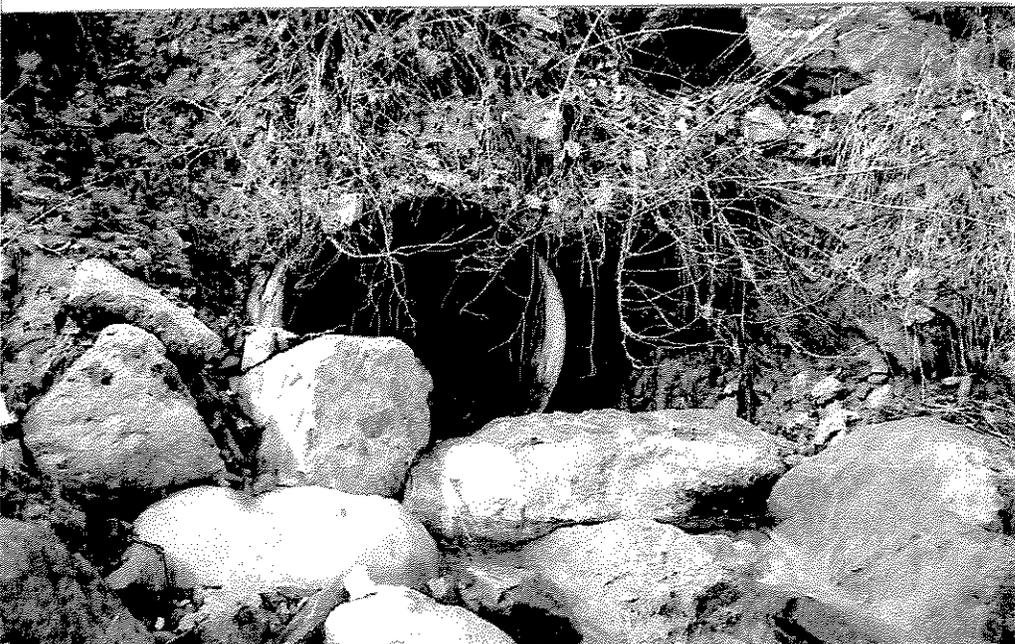
Top: US-19 before treatment

Bottom: US-19 after treatment

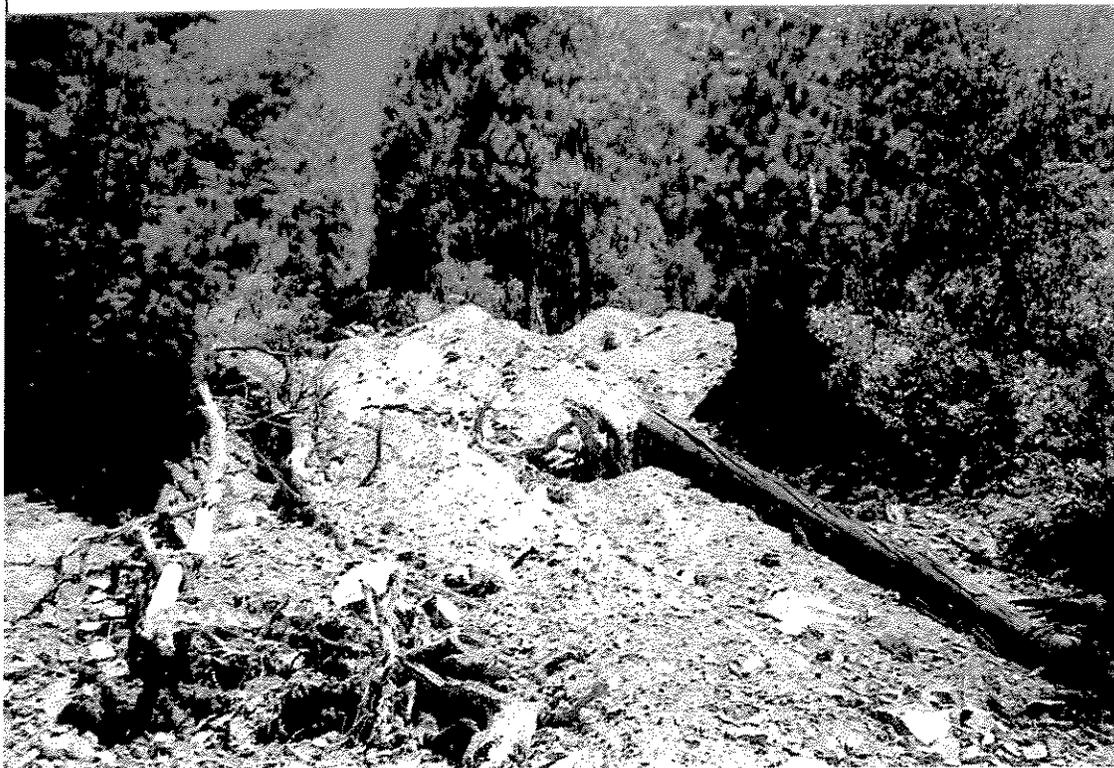
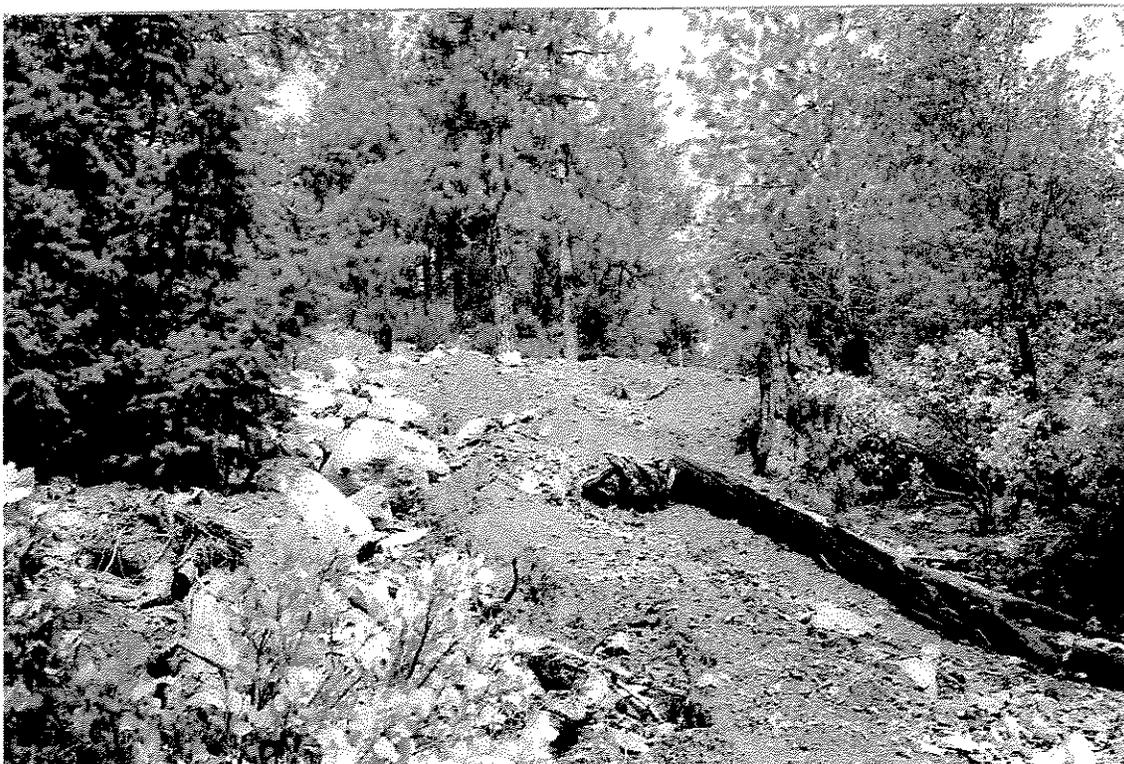
Top: Site US-18 before treatment
Bottom: Site US-18 after treatment

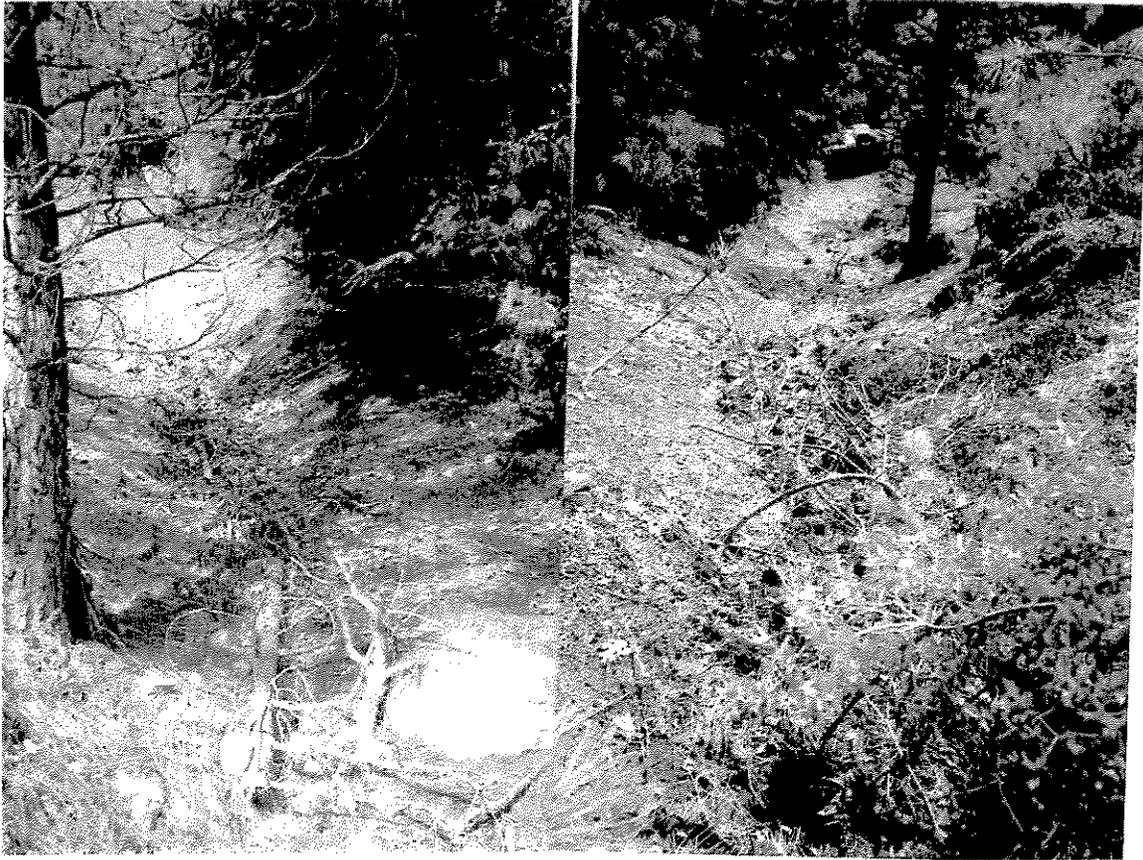
Both photos: Site US20 at source. Vegetation/Debris placed in gully by EUHS students to successfully limit erosion.

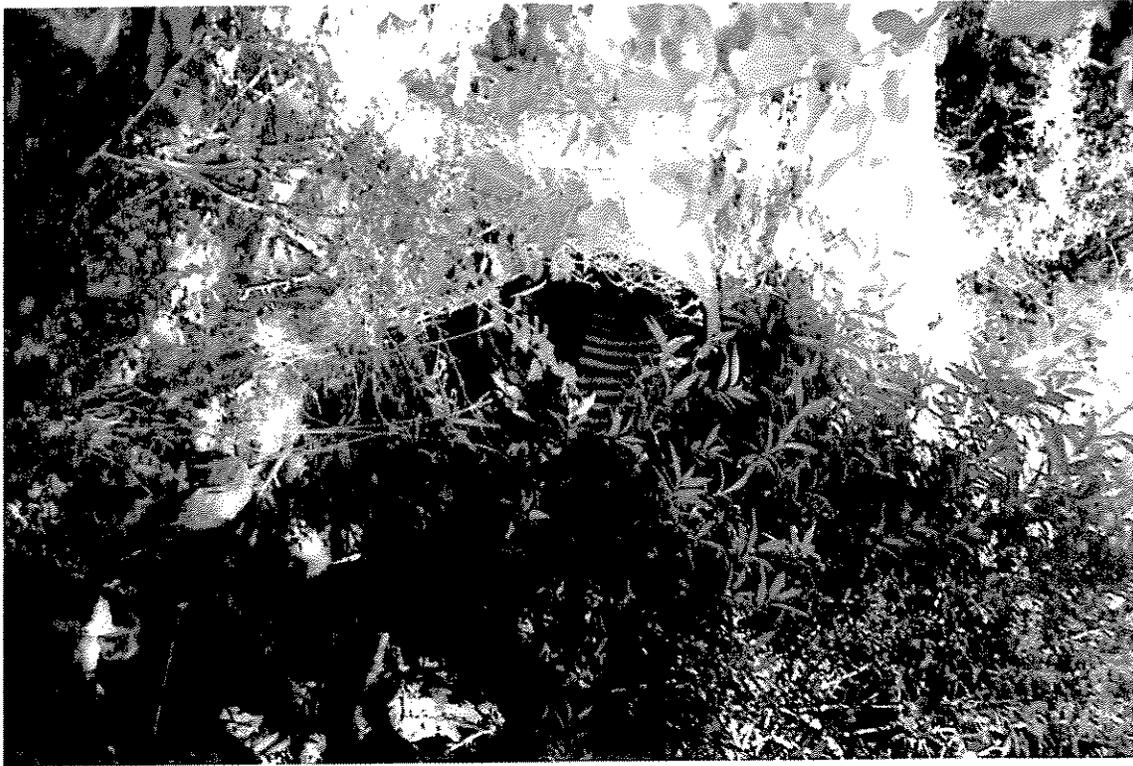
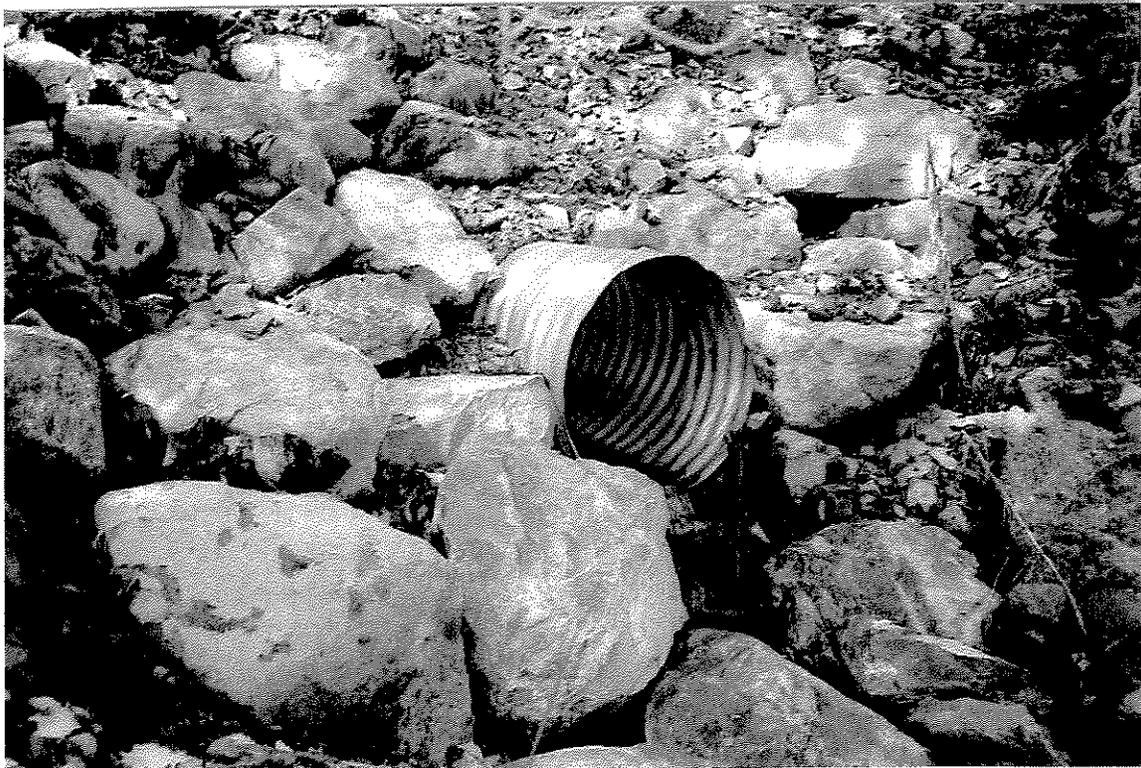
Top: US-23 before treatment

Bottom US-23 after treatment

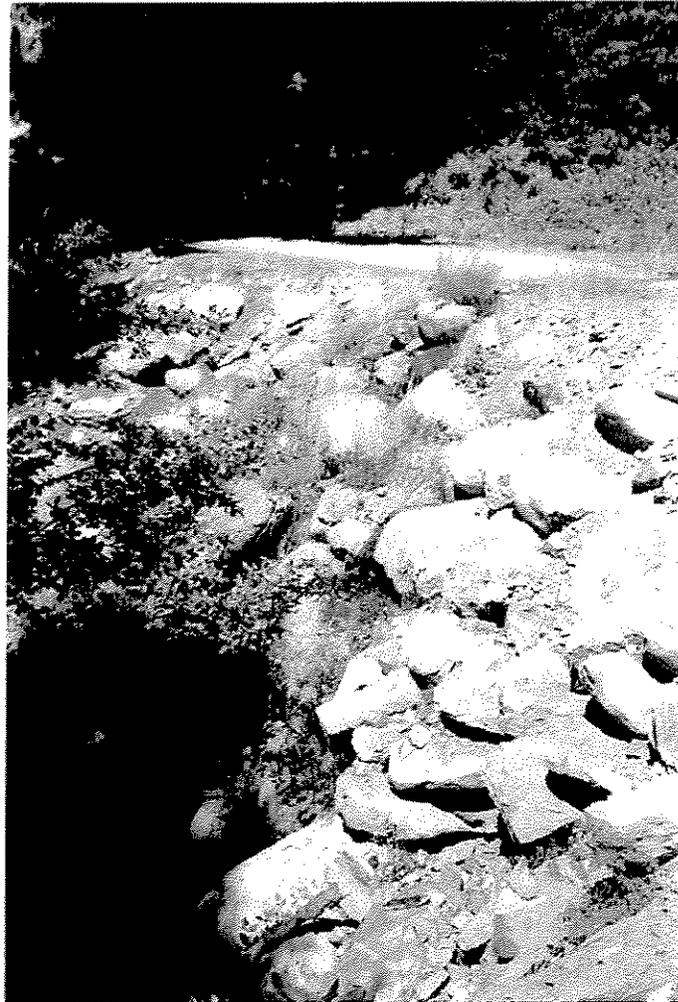
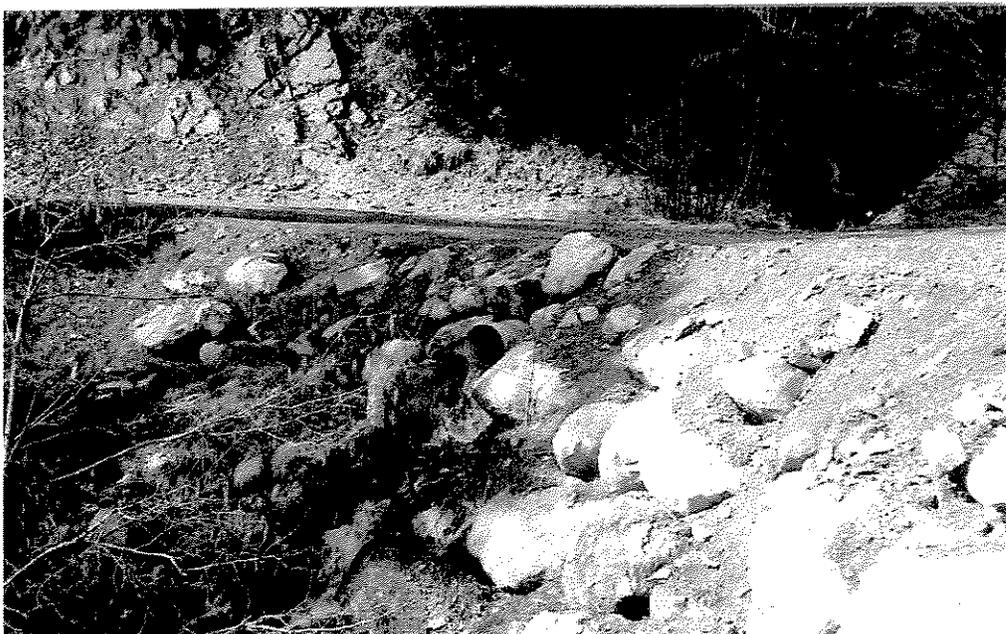
Top: Site US-25 before treatment

Bottom: US-25 after treatment – culvert installation

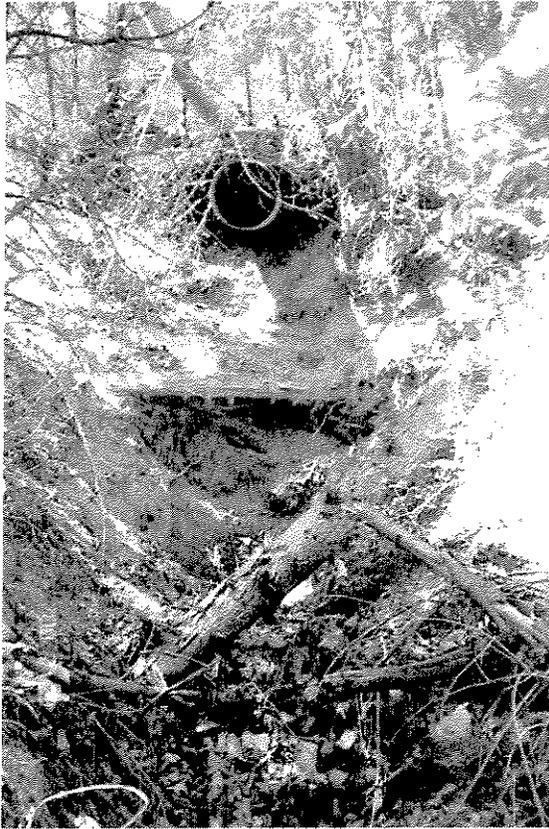
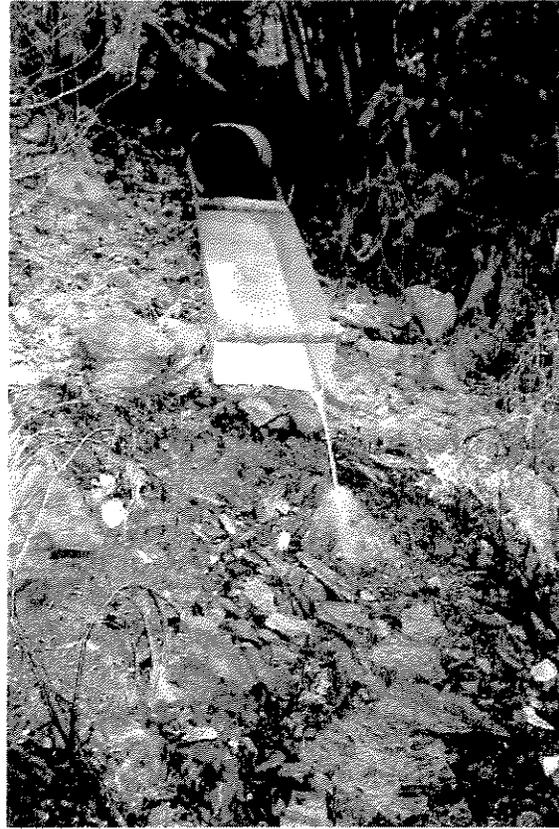
Left: Site US1-12 fill side before treatment

Right: Site US-12 fill side after treatment

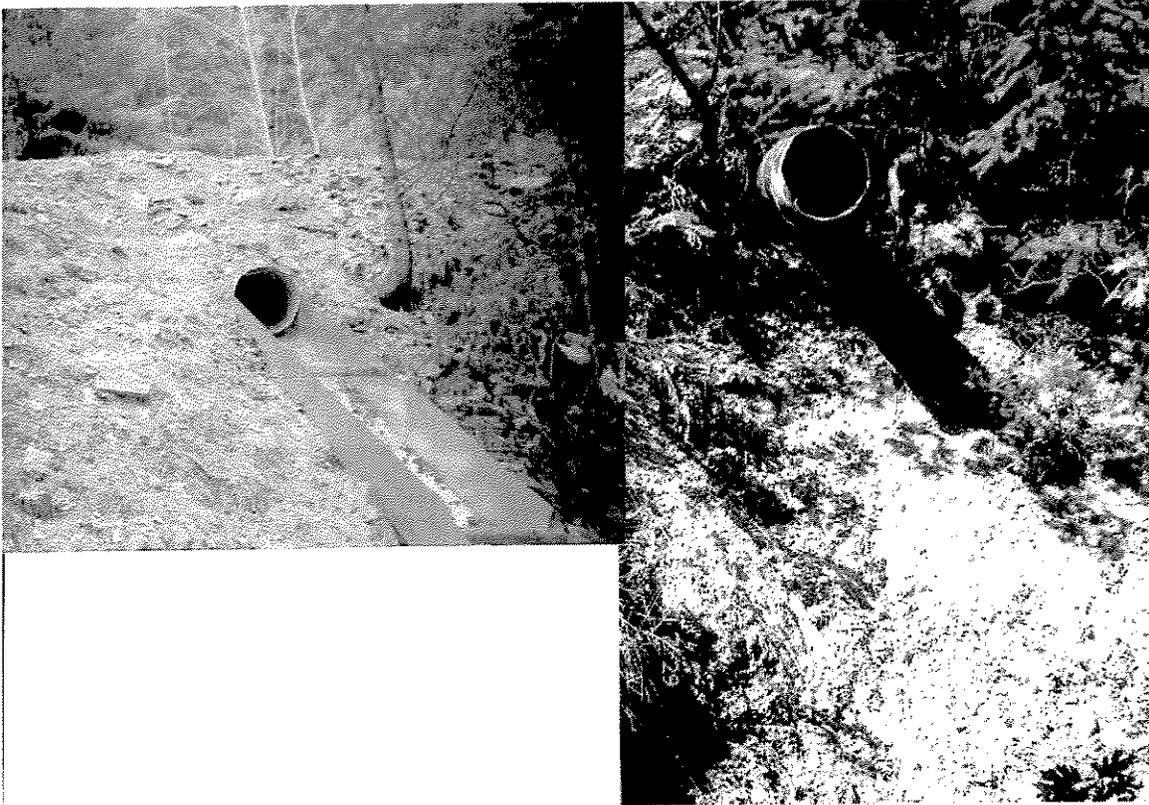
Left: Site US1-19 After treatment

Right: Site US1-19 Before treatment
